Branch River Smallmouth Bass Survey-2009

Steve Hogler and Steve Surendonk
WDNR-Mishicot, WI.

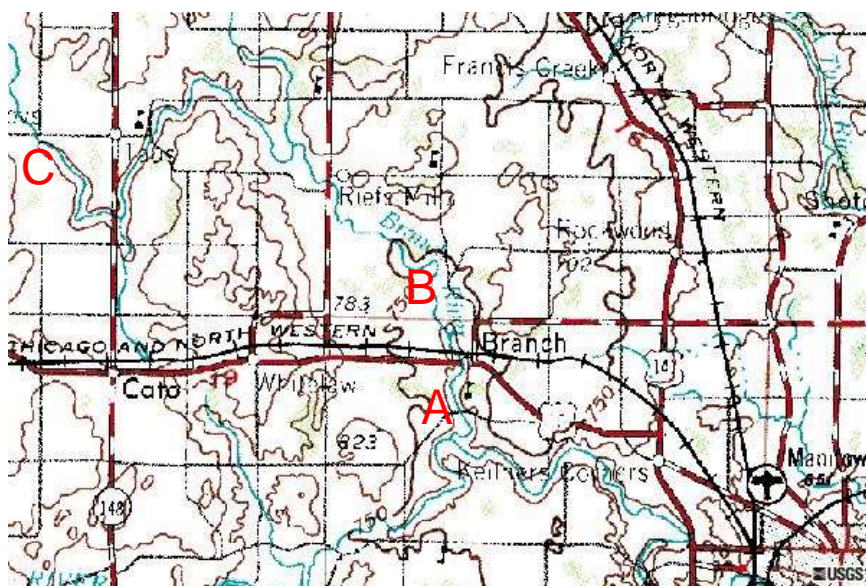
Three locations were selected as survey sites for this study and all were within the stream reach identified as smallmouth bass waters. The selected sites were upstream of North Union Road, Danmar Road and Reifs Mill Road (Figure 1).

Figure 1. The location of our survey sites on the Branch River that were sampled in 2009 to assess the smallmouth bass population of the river. Site A was upstream of North Union Road, site B was upstream of Danmar Road and site C was upstream of Reifs Mill Road.

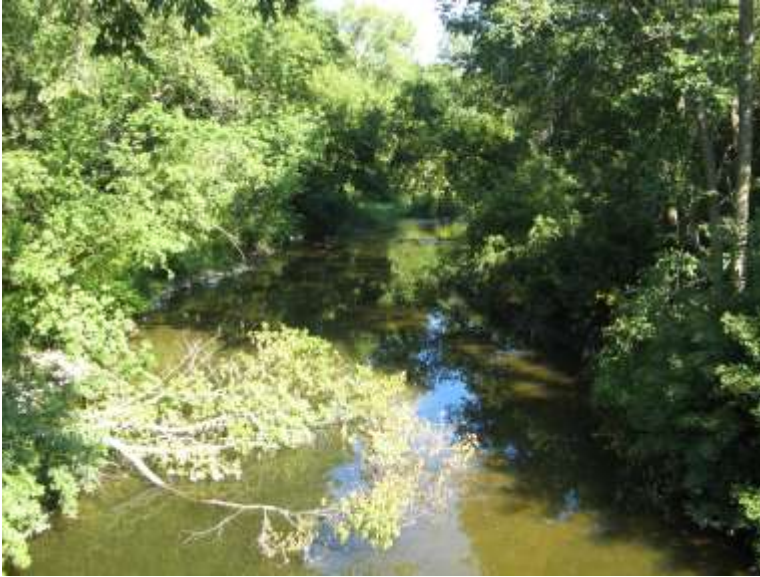
The Branch River at this location is a 4th order stream that runs through a private golf course. However, the stream banks are well buffered with trees, shrubs and non-mowed grasses (Figure 2). Average stream width at this location is 25 meters and several sections of river have been channelized (10%) and rip-rapped near golf course crossings. The stream has a gradient of 1.98 meters per kilometer and a sinuosity of 1.57:1.

Figure 2. The Branch River runs through golf course at North Union Road, although stream banks are well buffered.

Following shocking, staff evaluated stream habitat using the qualitative habitat scoring sheet. At this location, the river had high rankings for buffer width, limited bank erosion and diverse habitat. It scored somewhat lower because the survey section lacked deep runs. Overall the stream at this location scored 77 points indicating very good qualitative habitat.

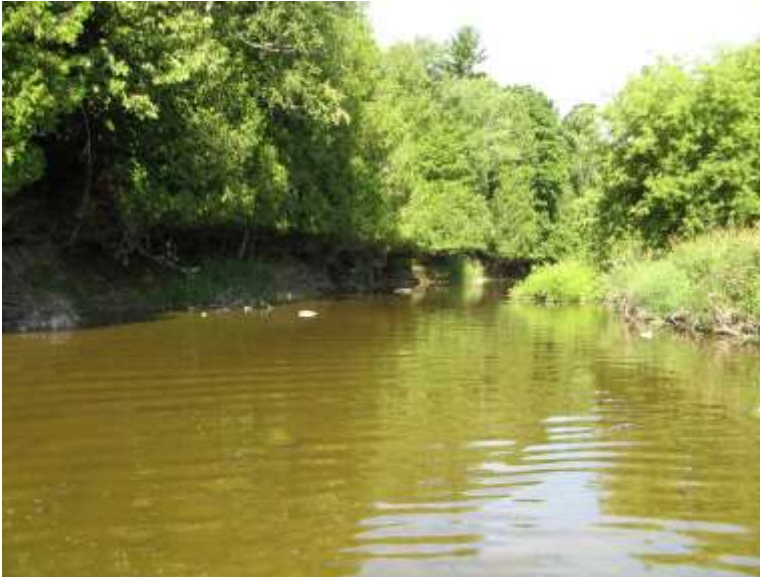
At Danmar Road, the Branch River is a 4th order stream that flows through a woodland landscape (Figure 3). The Branch River at this location has a gradient of 1.59 meters per kilometer and a sinuosity of 1.46:1.

Figure 3. The Branch River runs through woodland above Danmar Road.

Stream habitat using the qualitative habitat scoring sheet was evaluated following shocking. At this location, the river had high rankings for buffer width and limited bank erosion. The site scored somewhat lower because of shallow depth. Overall, the stream at this location scored 82 points indicating excellent qualitative habitat for warmwater fish.

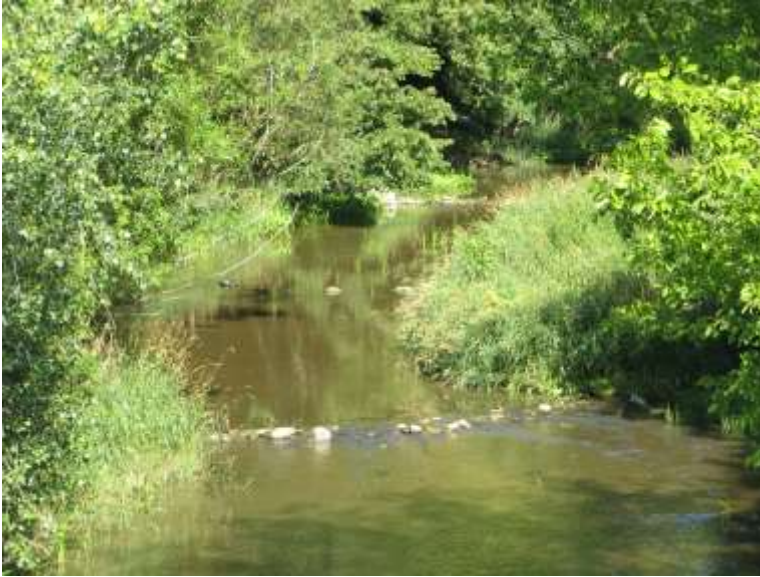
At this location, the Branch River is a 3rd order stream that flows through an agricultural landscape with a forest, shrub and grass buffer (Figure 4). Stream width at this location varied between 10 m and 20 m wide, the gradient was 0.53 meters per kilometer and the river had a sinuosity of 2.25:1.

Figure 4. Looking upstream at the Branch River from Reifs Mill Road.

Stream habitat using the qualitative habitat scoring sheet was evaluated following shocking. At this location, the river had high rankings for buffer width and limited bank erosion. The site scored somewhat lower for shallow depth, limited fish cover and the lack of pools. Overall, the stream at this location scored 58 points indicating good qualitative habitat for warmwater fish.
